## HOME INSPECTION REPORT

# 9 Crest Hollow Lane

Longmeadow, MA, 01106

Report SAMPLE-ESTATE · Final report

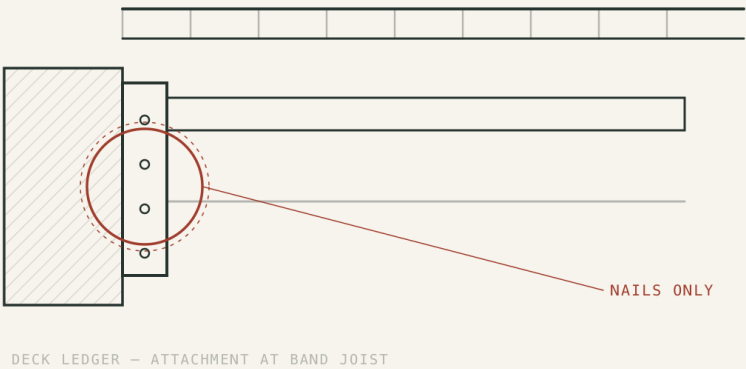
FIG. X-1

Terrace deck ledger relies on nail-only attachment

The elevated rear terrace's ledger board is attached to the band joist with nails only — no lag screws or through-bolts were visible at the accessible portion, and no ledger flashing was observed above it. Ledger attachment is the most common failure point in elevated deck collapses, and this terrace stands over a walk-out patio.

Deck ledger — nail-only attachment

Have a qualified contractor retrofit the ledger with properly spaced structural fasteners and add ledger flashing. Until the attachment is verified, avoid concentrated gatherings on the terrace.

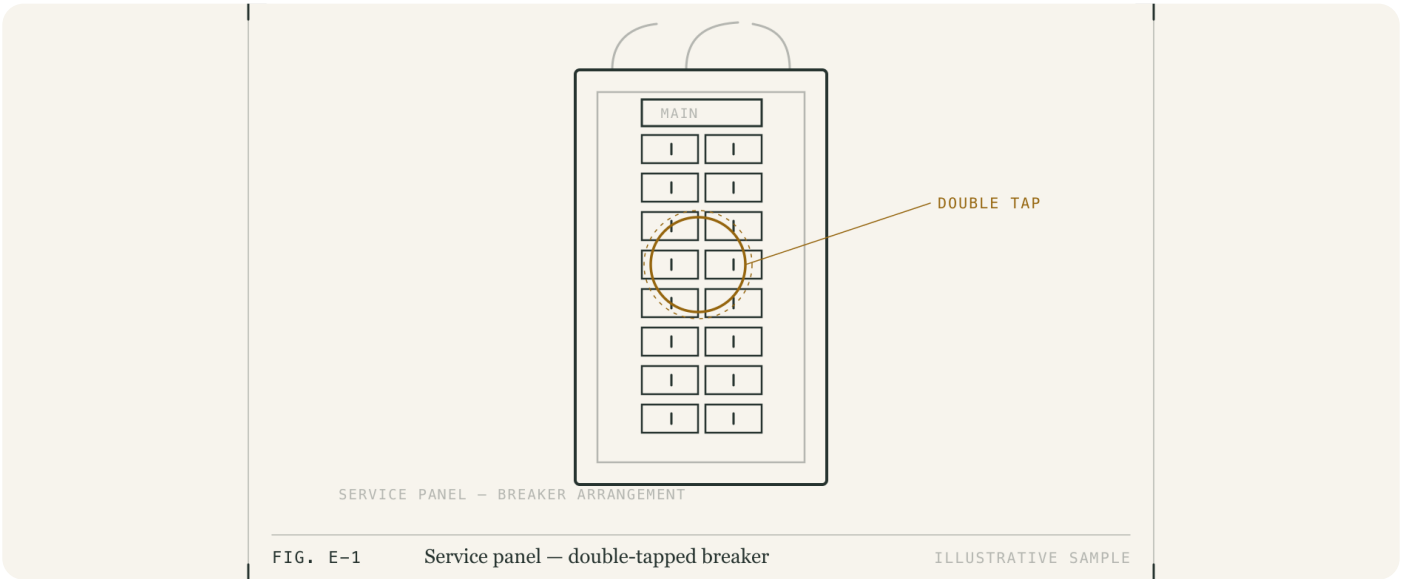
Double-tapped breaker in the garage subpanel

One breaker in the garage subpanel serves two conductors under a single lug — likely added when the EV charging circuit was installed. The breaker is not listed for two conductors, and this connection point can loosen and overheat over time.

Have an electrician move one conductor to its own breaker. A single open position remains in this subpanel, so the correction is straightforward.

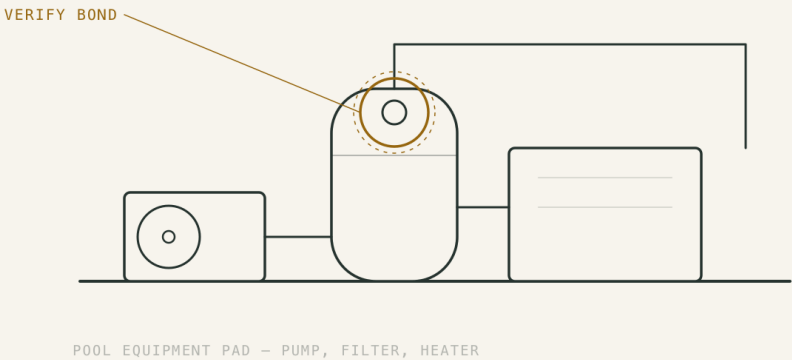
**MAJOR DEFECT** Equipment bonding continuity could not be verified

The pool equipment pad is orderly and the pump, filter, and heater all operated normally. However, the bonding conductor at the heater's bonding lug was disconnected, and continuity of the equipotential bonding grid could not be verified by visual inspection.

FIG. Q-1 Pool equipment — bonding continuity ILLUSTRATIVE SAMPLE

Have a licensed electrician reconnect the bonding conductor and verify continuity of the bonding grid across all pool equipment. Bonding is the system that keeps every touchable metal surface at the same electrical potential — it protects swimmers, and it must be intact.
