## HOME INSPECTION REPORT

# 418 Stonebrook Lane

Springfield, MA, 01101

Report SAMPLE-COLONIAL · Final report

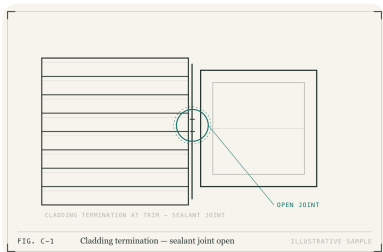
Sealant joints open at cladding-to-trim transitions

Location: Window trim, south and west elevations

Perimeter sealant at several window and trim transitions has weathered and pulled away, leaving open joints on the south and west elevations. No moisture staining was observed on interior finishes adjacent to these openings.

Cut out failed sealant and re-seal the open joints as part of seasonal maintenance to keep bulk water out of the wall assembly.

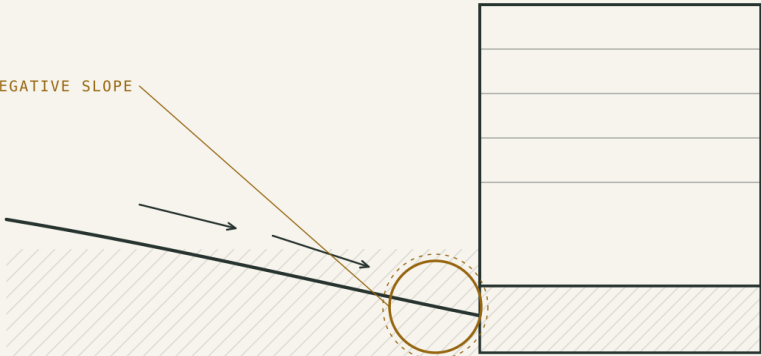
FIG. G-1 Surface grading — slope toward foundation

Grade slopes toward the foundation at the rear patio

Location: Rear elevation, patio edge

Surface grading along roughly twelve feet of the rear elevation directs runoff toward the foundation rather than away from it. The interior foundation wall in this area showed no elevated moisture readings at the time of inspection, but the drainage pattern will work against the house every storm.

NEGATIVE SLOPE

Regrade the affected area to fall away from the foundation — a minimum of six inches over the first ten feet is the common guideline — and extend the nearest downspout so roof runoff discharges beyond the regraded slope.

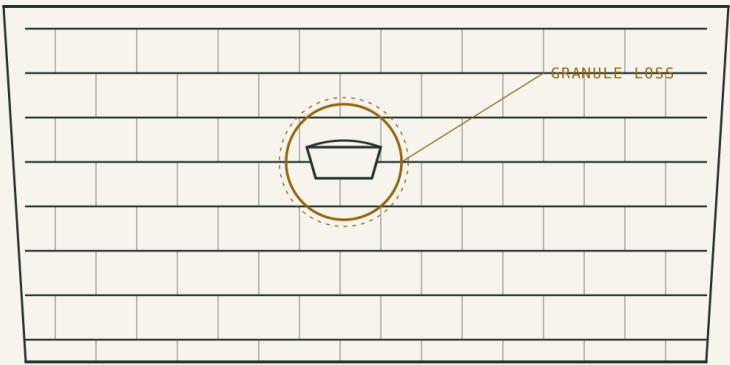
FIG. R-1

Shingle granule loss concentrated on the south slope

Location: South roof slope

The architectural shingles on the south-facing slope show accelerated granule loss and exposed asphalt in scattered patches, heaviest near the ridge. The north slope retains most of its granule surface. No active leakage was visible in the attic below at the time of inspection.

Roof covering — field wear at south slope

Have a licensed roofing contractor evaluate the south slope and provide a repair-versus-replacement opinion with remaining-life context. Budget planning should assume covering replacement on this slope within the next few seasons.

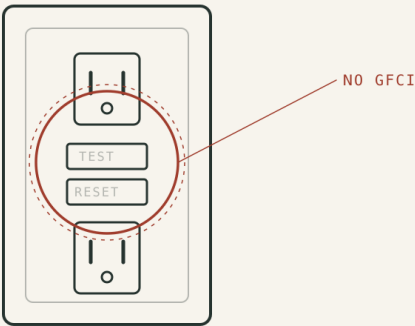
**SAFETY** No GFCI protection at exterior and garage receptacles

Location: Exterior receptacles; garage

The exterior receptacles and the garage receptacles are not protected by ground-fault circuit interrupters. These are wet and damp locations where GFCI protection is the current safety standard; the home predates the requirement.

FIG. E-3 Wet-area receptacle — no ground-fault protection ILLUSTRATIVE SAMPLE

Have a licensed electrician add GFCI protection at the exterior and garage receptacles. This is an inexpensive upgrade with a meaningful shock-safety benefit.

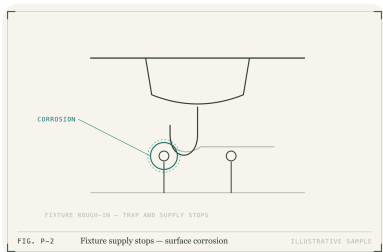
Surface corrosion at fixture supply stops

Location: Kitchen sink; hall bathroom

The angle stops under the kitchen sink and hall bathroom lavatory show surface corrosion at the compression fittings. No active leakage was present, but corroded stops are less likely to close fully when they are eventually needed.

Replace the corroded angle stops during routine plumbing service so each fixture can be isolated reliably in an emergency.

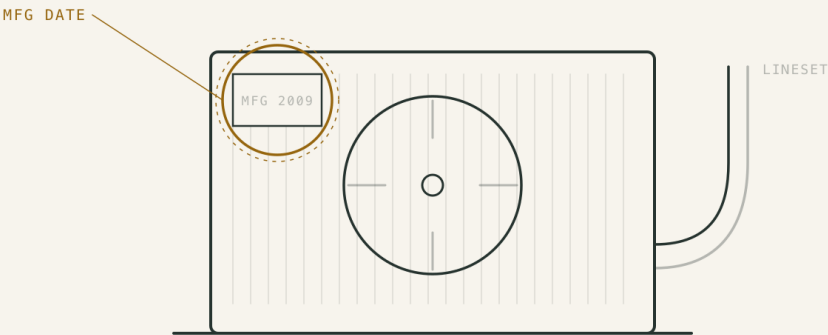
Air-conditioning condenser at its service-life horizon

Location: Rear yard, condenser pad

The outdoor condensing unit's data plate shows a 2009 manufacture date. The system cooled normally during testing, but at this age the unit is operating beyond the typical 12–15 year design life, and the refrigerant it uses has been phased out, which raises the cost of future repairs.

FIG. H-1 Cooling — condenser at service-life horizon ILLUSTRATIVE SAMPLE

Budget for condenser replacement rather than major repair. A qualified HVAC contractor can quote replacement now so an eventual failure becomes a scheduled project instead of an emergency.
