## HOME INSPECTION REPORT

# 118 Fieldstone Way

Wilbraham, MA, 01095

Report SAMPLE-NEWBUILD · Final report

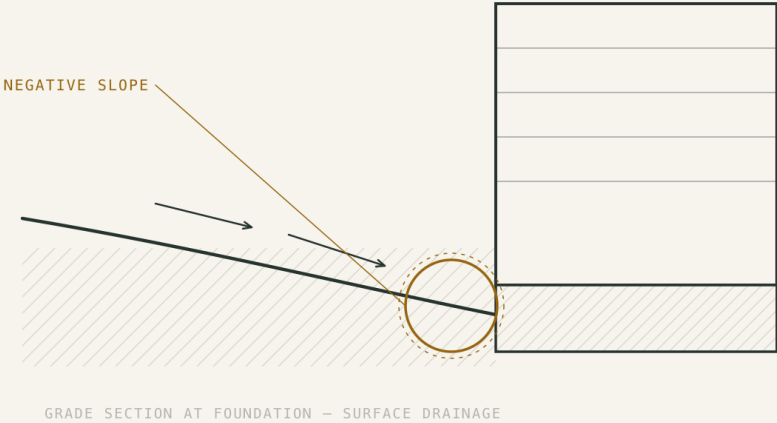
FIG. G-1 Surface grading — slope toward foundation

Final grade slopes toward the foundation at the rear patio

Location: Rear elevation at patio

Final grading was not complete at the time of inspection: along the rear patio the grade currently directs runoff toward the foundation. New-construction backfill also settles over the first seasons, which will make this worse before it makes it better.

Builder item: complete final grading to fall away from the foundation and confirm the swale between lots carries water to the street. Re-check after the first heavy rain and again at the eleven-month warranty walkthrough.

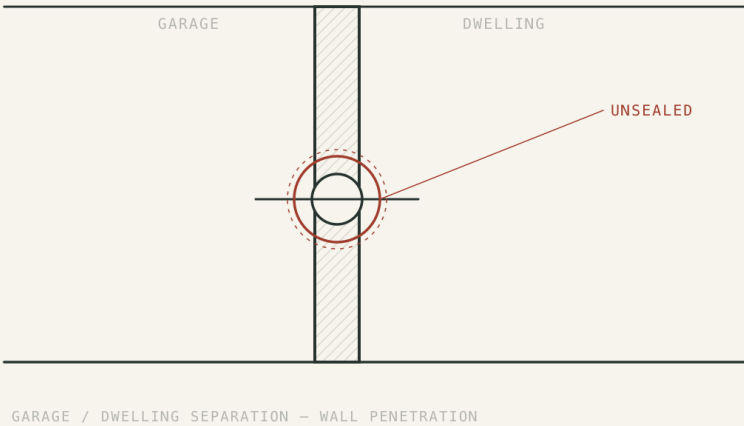
FIG. F-1

Unsealed penetration in the garage/dwelling separation

Location: Garage, wall to utility room

A conduit penetration through the garage-to-dwelling separation wall is not fire-sealed. The separation wall is the assembly that slows a garage fire from reaching the living space, and every penetration through it must be sealed with an approved material.

Garage separation — unsealed penetration

Builder item: seal the penetration with an approved fire-rated sealant before closing. Verify at the completion walkthrough.

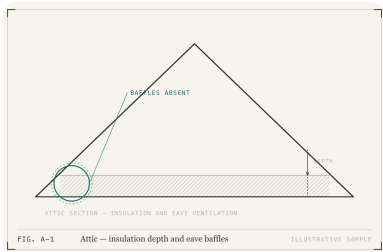
Insulation baffles missing at four eave bays

Location: Attic, north eave

Four eave bays on the north side lack ventilation baffles, and blown insulation is blocking soffit airflow at those bays. The remainder of the attic meets the insulation specification on the builder's certificate.

Builder item: install baffles at the four affected bays and redistribute the insulation.
