## HOME INSPECTION REPORT

# 12 Alder Terrace

Inspected by Sam Stone · March 14, 2026

Report SAMPLE-CAPE · Final report

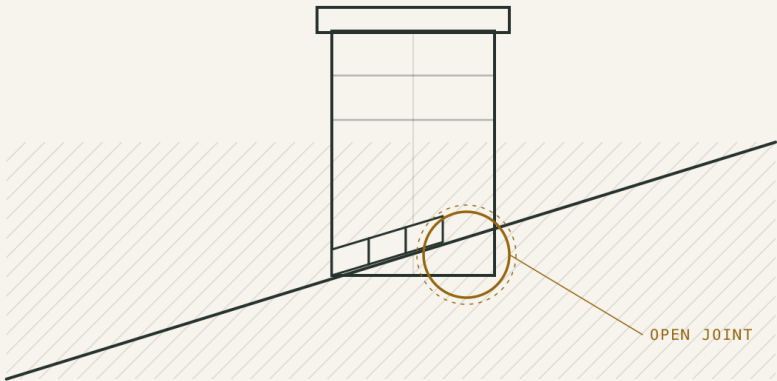
FIG. R-2 Chimney step flashing — open joint

**MAJOR DEFECT** Open joint in the chimney step flashing

Location: Chimney, up-slope side

One step-flashing joint on the up-slope side of the chimney is open where sealant has failed and a flashing piece has lifted. Light staining on the roof sheathing directly below, visible from the attic, indicates minor intermittent entry during wind-driven rain.

**RECOMMENDATION**

Have a roofer reset and reseal the chimney step flashing. Left open, this joint will eventually stain the second-floor ceiling below.

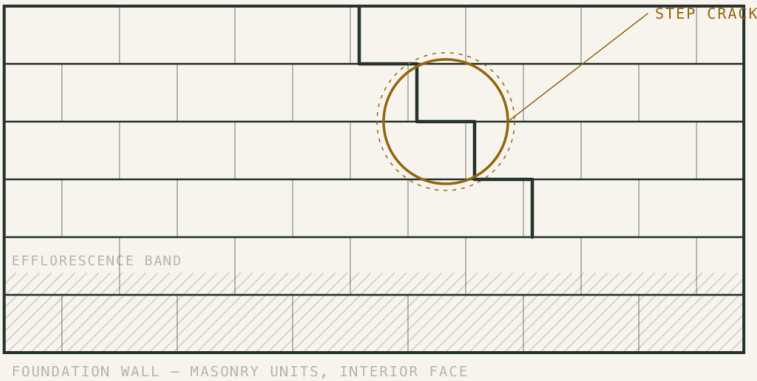
FIG. S-1 Foundation wall — step cracking and moisture band ILLUSTRATIVE SAMPLE

Step cracking with a seasonal moisture band at the northeast corner

Location: Northeast foundation corner

Step cracking follows the mortar joints at the northeast corner of the block foundation, with an efflorescence band along the base of the wall indicating recurring seasonal moisture rather than a single event. The crack pattern is consistent with minor settlement; no displacement or bowing was measured. Framing above probed sound.

RECOMMENDATION

Address the water first: correct the short downspout at this corner and re-establish positive grade. Then have a foundation contractor evaluate and repoint the cracked joints, and monitor annually for any change in width.

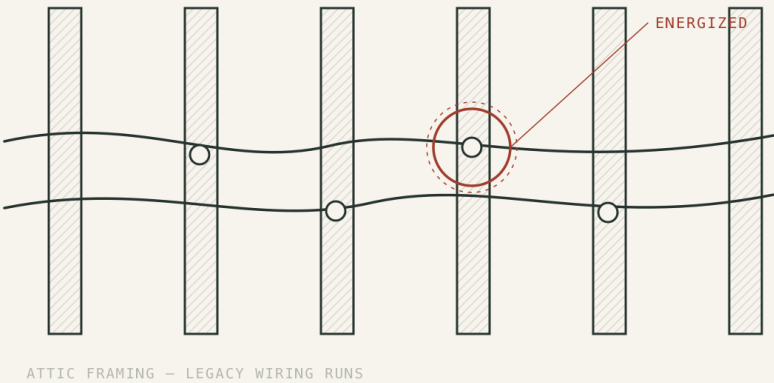
FIG. E-4 Attic wiring — knob-and-tube circuits in service ILLUSTRATIVE SAMPLE

Knob-and-tube wiring in service in the attic

Location: Attic; traced to two second-floor circuits

Original knob-and-tube wiring remains energized in the attic, serving at least two second-floor lighting circuits. The visible runs are intact and workmanlike, but this wiring method has no grounding conductor, and its insulation is now more than seventy years old. Several runs pass under later blown-in insulation, which this wiring type is not rated for.

RECOMMENDATION

Have a licensed electrician evaluate all knob-and-tube circuits and price replacement. Insurers commonly restrict coverage on homes with active knob-and-tube, so resolving this belongs in your closing timeline, not after it.

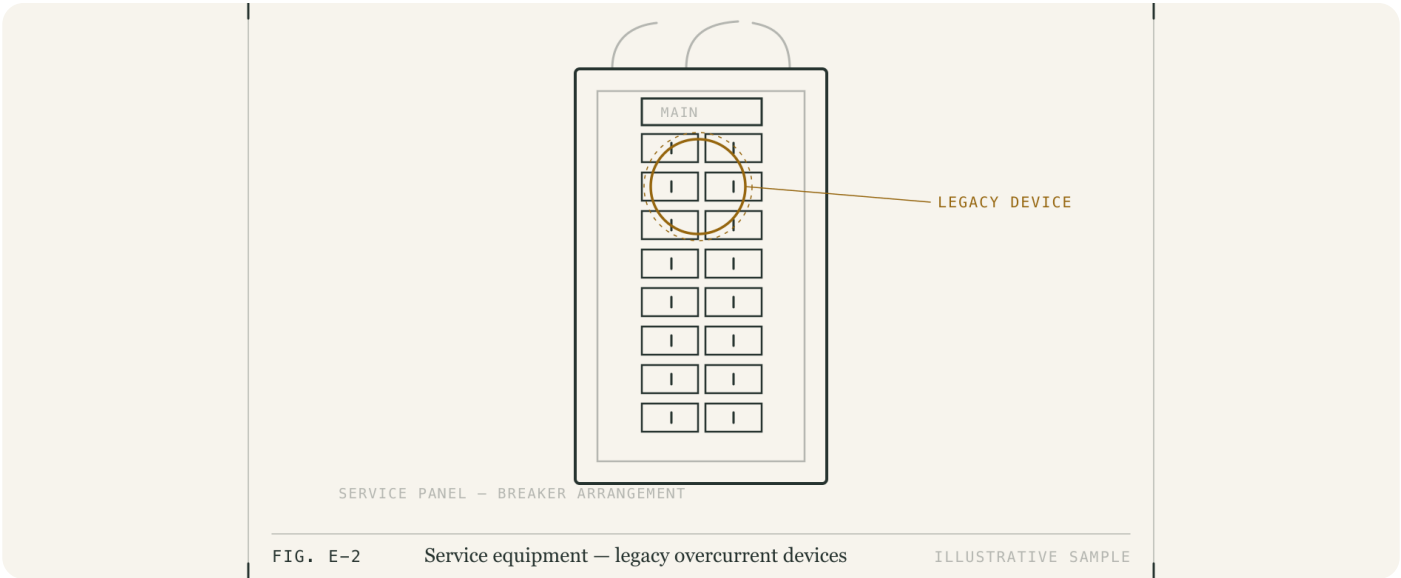
Fuse-based service equipment with limited capacity

Location: Basement, service panel

The home is served by 60-amp fuse-based service equipment. The panel is original, has no open positions, and several circuits serve multiple rooms. No scorching or overfusing was observed, but capacity is limited for modern loads.

RECOMMENDATION

Plan a service upgrade to a modern breaker panel with a licensed electrician. This pairs naturally with the knob-and-tube evaluation and is often quoted as one project.

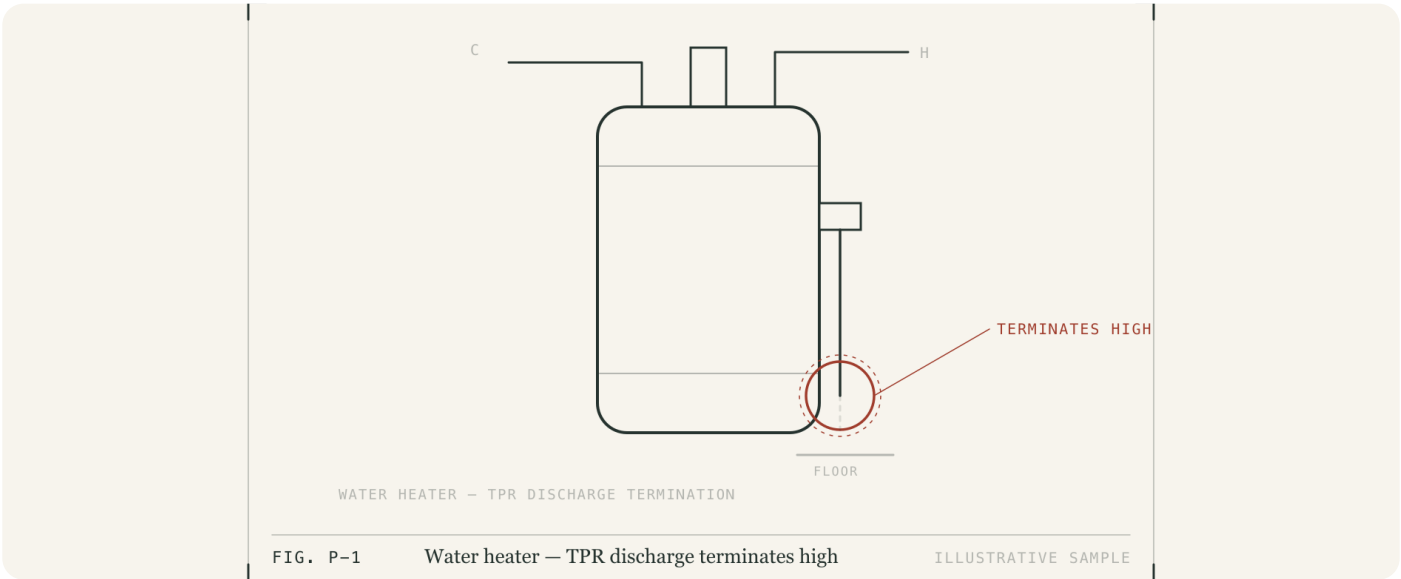
Water heater TPR discharge terminates too high

Location: Basement, water heater

The temperature-and-pressure relief valve's discharge pipe ends roughly thirty inches above the floor. If the valve ever discharges, scalding water would spray at that height rather than draining safely near the floor.

RECOMMENDATION

Extend the TPR discharge to within six inches of the floor using an approved material. This is a low-cost correction any plumber can complete quickly.

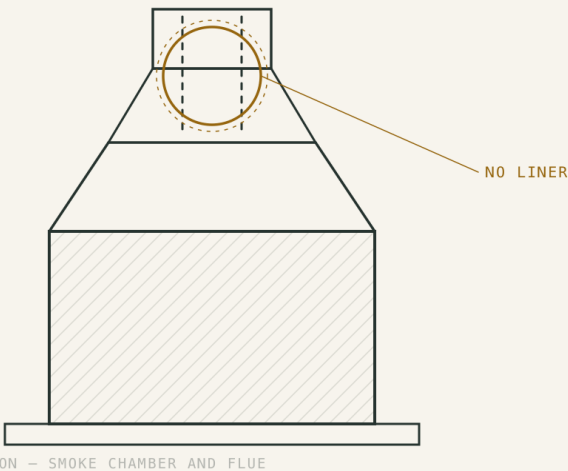
FIG. V-1

Masonry flue is unlined

Location: Living-room fireplace flue

The fireplace flue is original unlined masonry. Mortar joints visible from the firebox and from the attic chase show open gaps. Unlined flues allow combustion gases and heat to reach the masonry and adjacent framing, and do not meet the standard applied to active fireplaces today.

RECOMMENDATION

Do not use the fireplace until a chimney professional performs a Level II (camera) evaluation and quotes a liner. If you do not intend to use the fireplace, have the flue capped and note it as decorative.

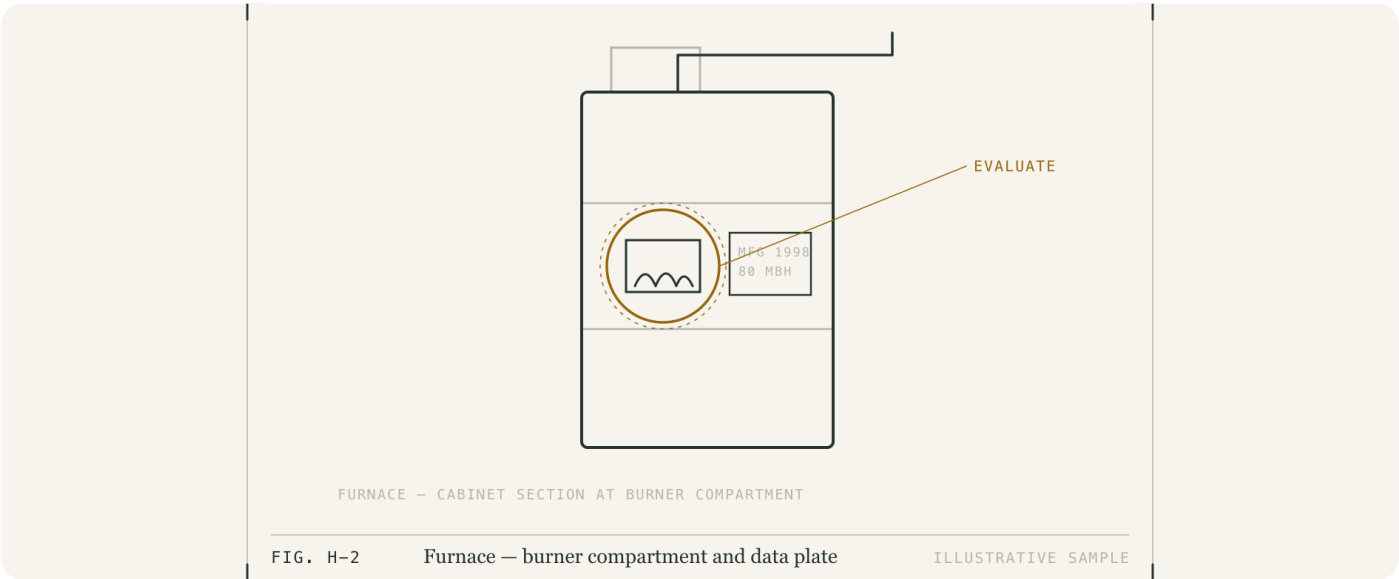
Furnace operating beyond its design service life

Location: Basement

The gas furnace's data plate shows a 1998 manufacture date — roughly a decade beyond typical design life. It fired and heated normally during the inspection, and no flame disturbance was observed, but a heat exchanger of this age warrants specialist evaluation, and replacement should be planned rather than assumed distant.

RECOMMENDATION

Have an HVAC contractor perform a combustion analysis and heat-exchanger evaluation now, and budget for replacement. An aging furnace that still runs is a planning item — until it isn't.

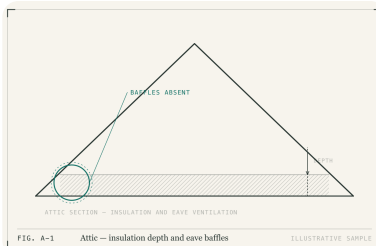
**MAINTENANCE****Attic insulation below guidance over original plaster ceilings**

Location: Attic

Attic insulation averages four to five inches and the eave bays lack baffles. Note that the knob-and-tube evaluation must come first: burying that wiring deeper is not an option.

**RECOMMENDATION**

Sequence this after the electrical work — wiring evaluation, then baffles, then insulation to current guidance. Done in order, one project enables the next.
